**STS-108
FLIGHT READINESS REVIEW**

NOVEMBER 15, 2001

Orbiter

AGENDA

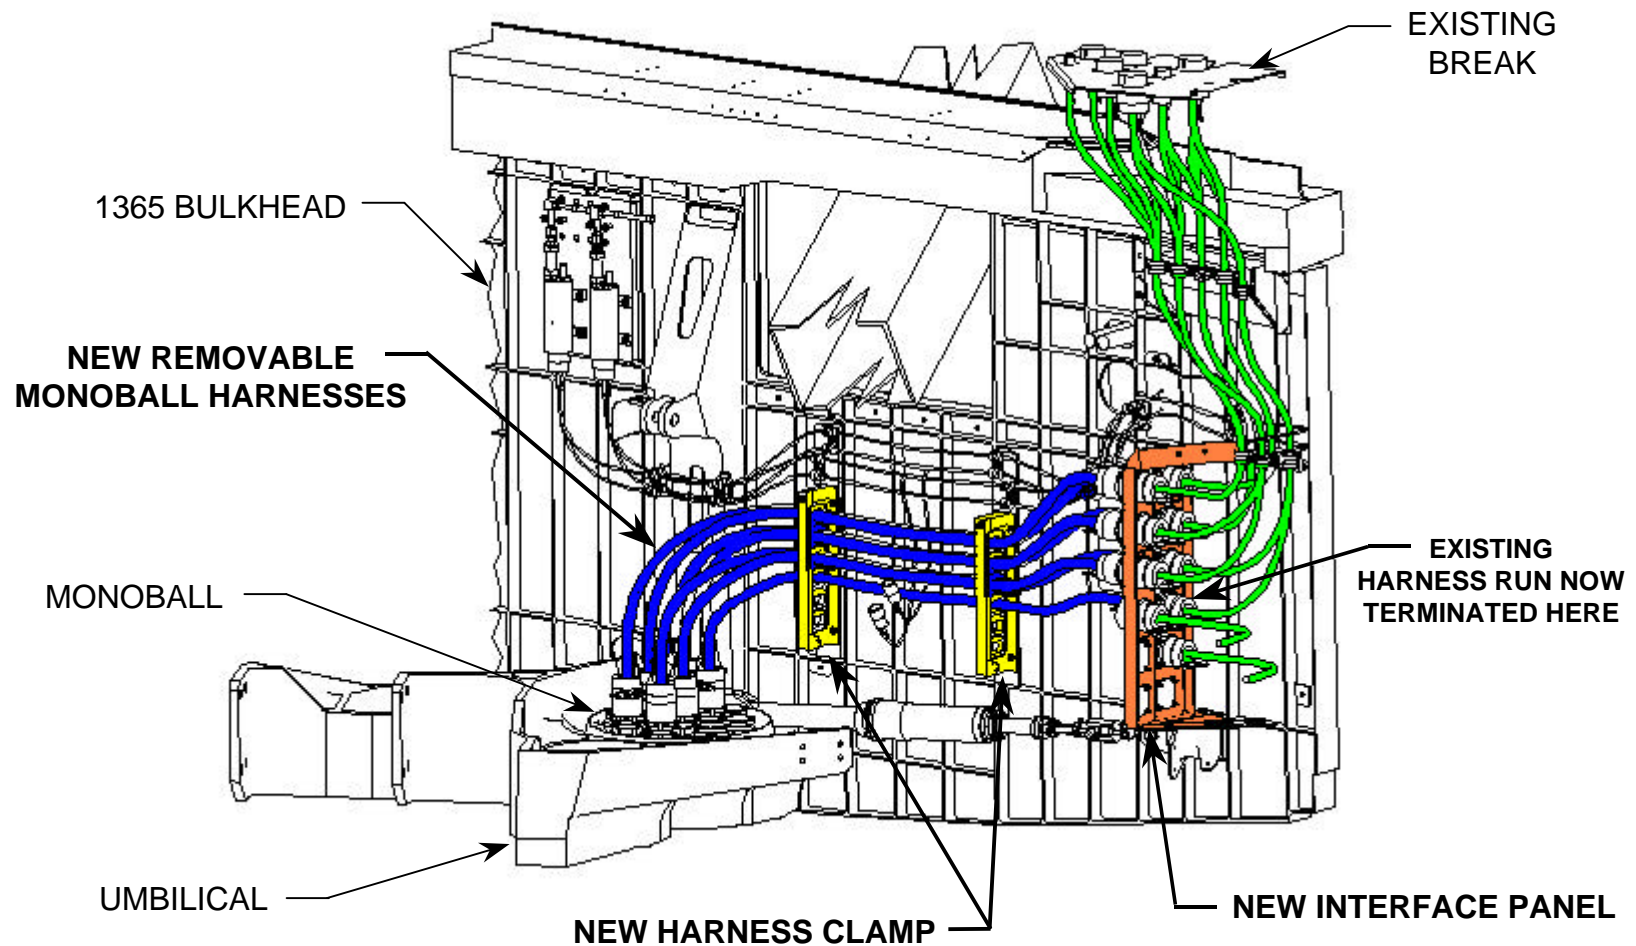
MONOBALL PRODUCTION BREAK HARDWARE

- The harnesses routed to the LH2 and LO2 electrical monoball are in a high traffic area and therefore vulnerable to damage during ground processing operations
 - The harnesses are demated from the monoball for access to the area and temporarily stowed locally, causing repeated harness flexing
- Modification adds a monoball wiring production break and removable monoball harnesses
 - Existing wiring is shortened and terminated at the new production break and new harnesses are routed from the production break to the monoball
 - Design allows these harness to be completely removed from the vehicle and protected during turnaround processing

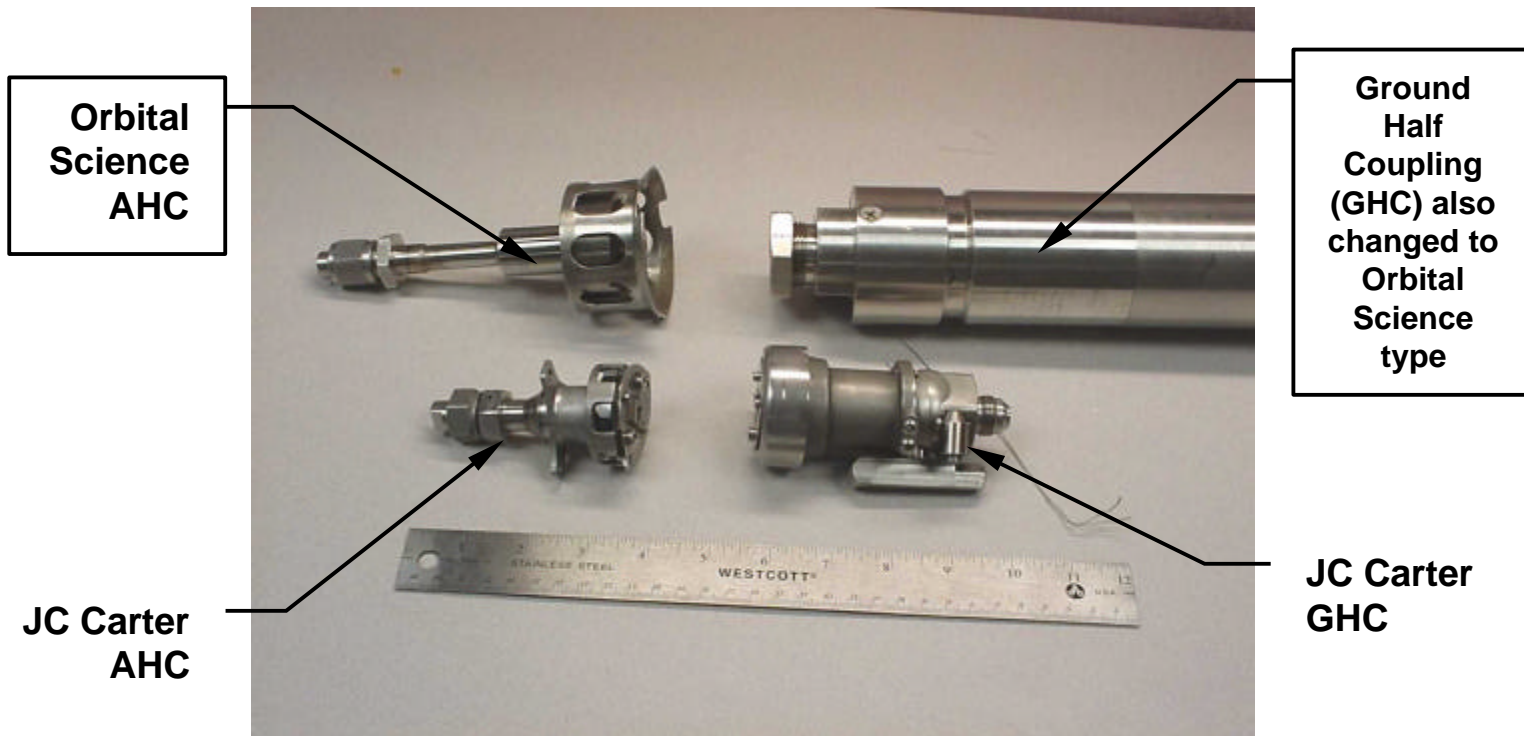
NEW ORBITAL SCIENCE COUPLINGS REPLACE JC CARTER COUPLINGS

- The existing design J.C. Carter AHC's have a history of poppet leakage, resulting in ~ 74 AHC R&R's in program history
 - Replacement requires an extensive amount of SCAPE ops activity in a limited work space area with high potential of collateral damage to adjacent area subsystem hardware

- The AHC has to be removed and sent to the HMF for poppet seal replacement, involving cutting and re-welding the housing
- Modification replaces the J.C. Carter AHC's with the more reliable Orbital Science AHC's currently used in the OMS/RCS system

- Only 6 OMS/RCS fuel AHC R&R's since return to flight
 - The AHC poppet seal replacement can be performed from outside the aft fuselage, at the servicing panel, without the need for recycling the AHC to the HMF for repair

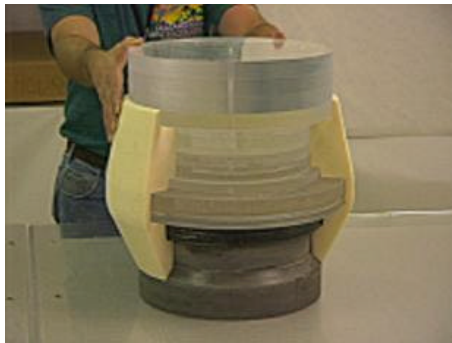
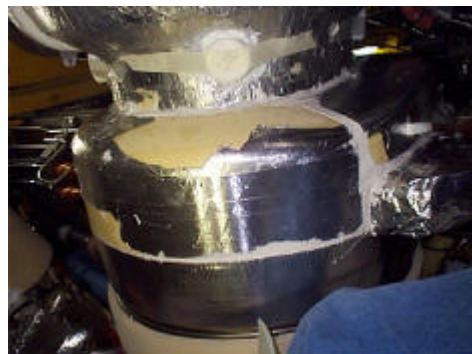
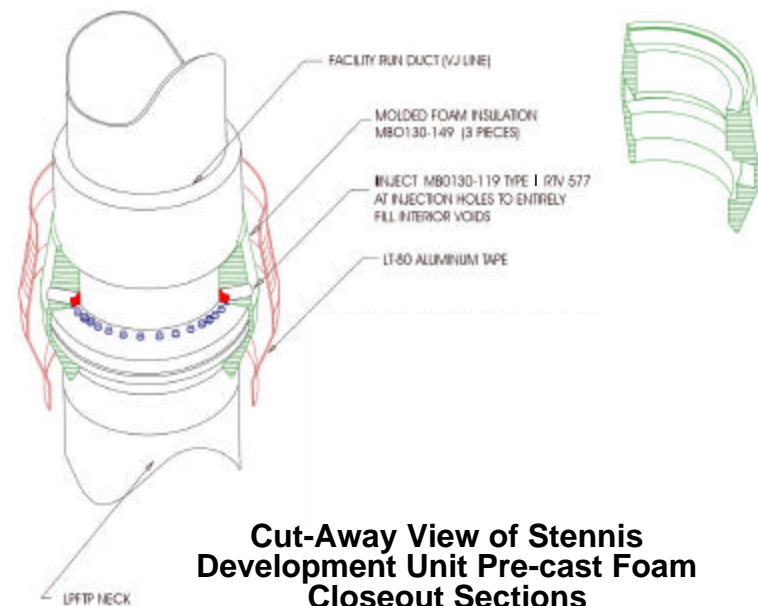
MPS/SSME INTERFACE PRE-CAST FOAM CLOSEOUT

- Hazardous operation requiring local clears during foam pour
 - Removal process generates dust and contaminate in the aft
- New pre-cast foam closeout sections for these joints greatly enhances installation and removal process and reduces process time

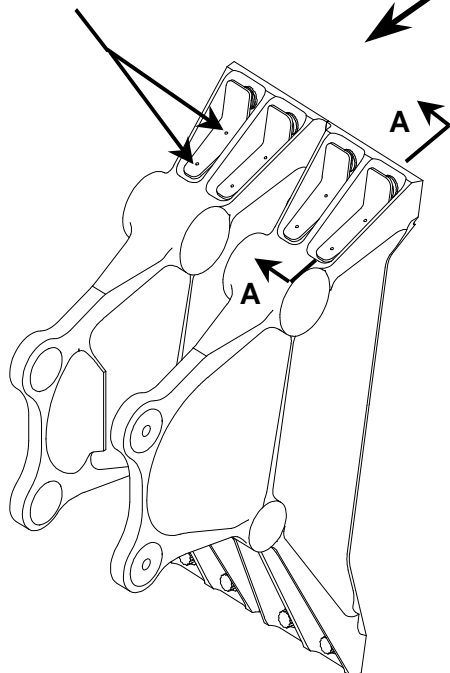
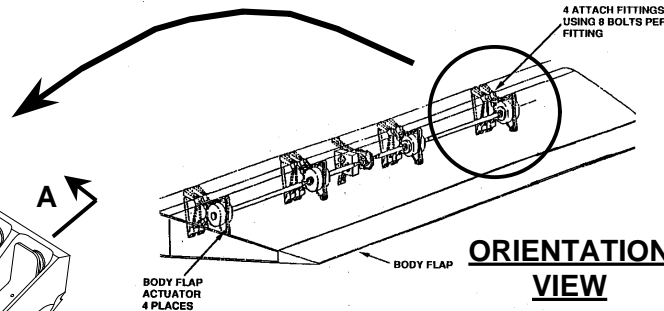
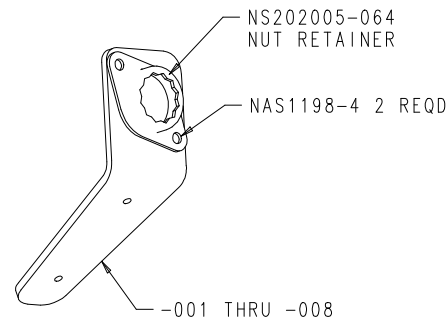
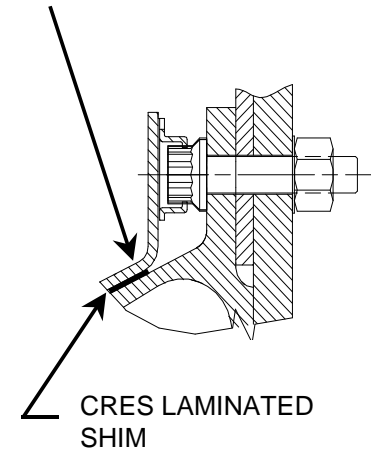
BODY FLAP ACTUATOR FITTING ANTI-SPIN RETAINER

- 17 of 32 bolt locations were modified this flow - the remainder will be worked at OMM
 - When completed, will significantly reduce the effort required to perform the torque check task and reduce the risk of access area collateral damage

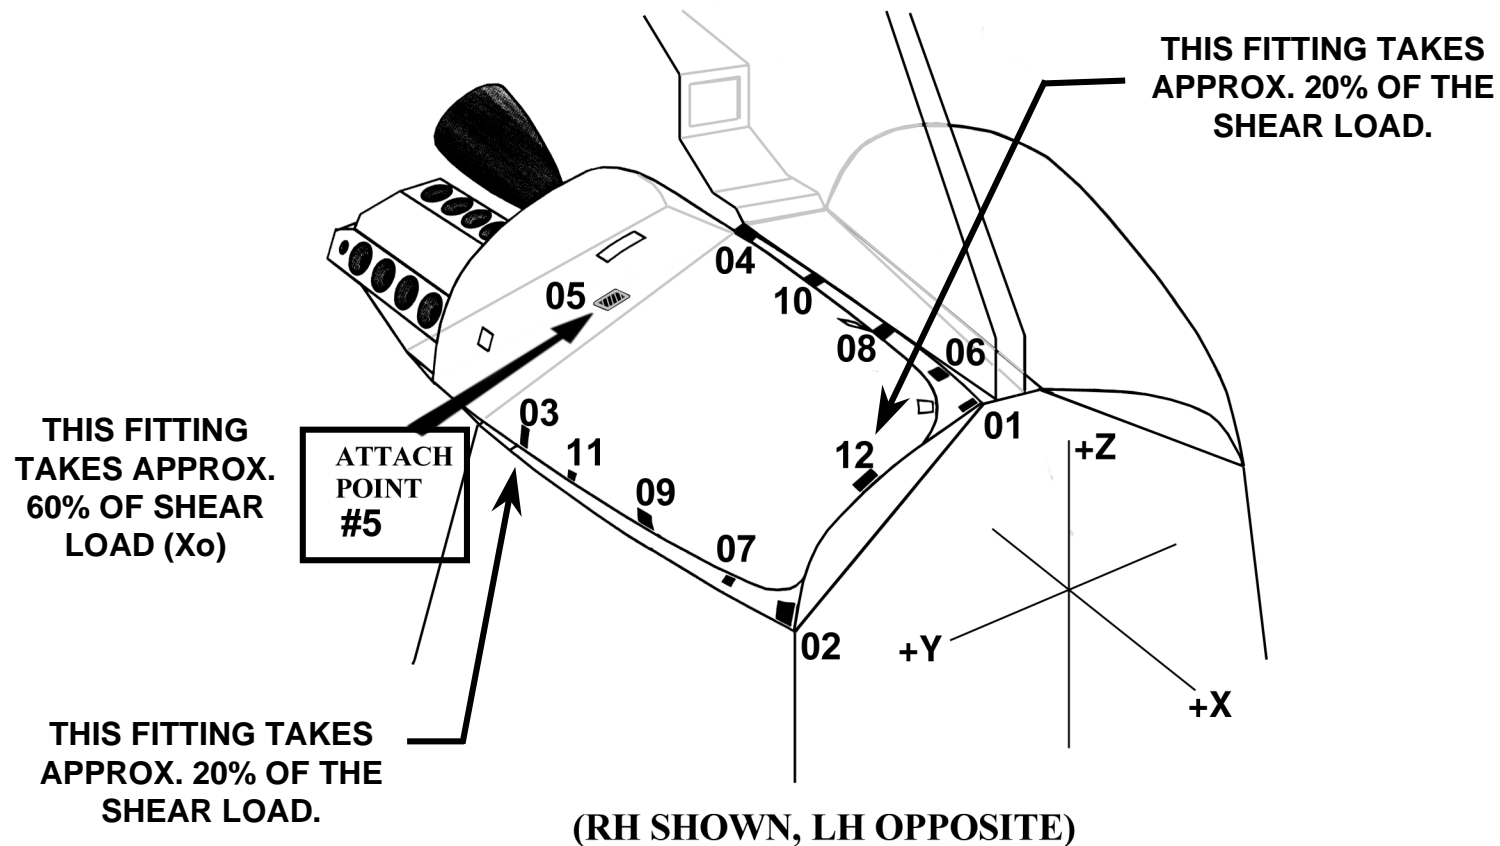
OMS Pod Shared Shear Load Locations

- Holes in the attach point 5 “puck” assembly on OMS pods LP05 and RP05 were found discrepant and elongated
 - Worst case hole elongation found on LP05 or RP05 was 0.030

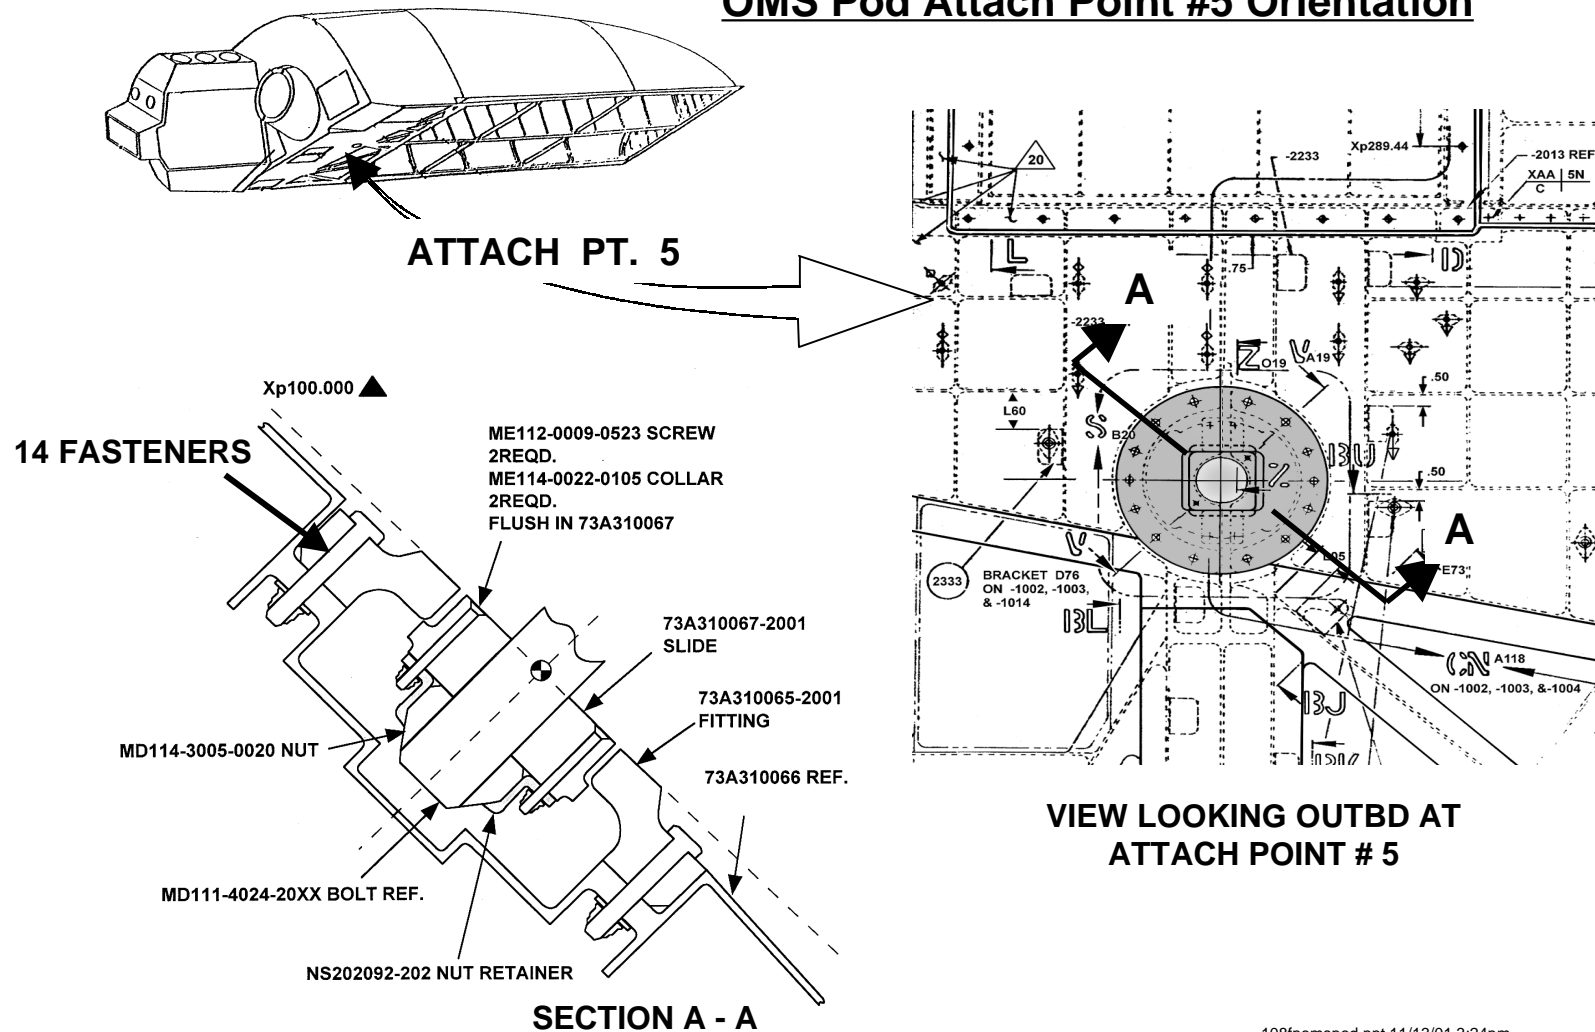
OMS Pod Attach Point #5 Orientation

Tests indicate all bolts and the OMS floor (through contact between puck and boss) would share the load prior to permanent deformation or failure of any bolt

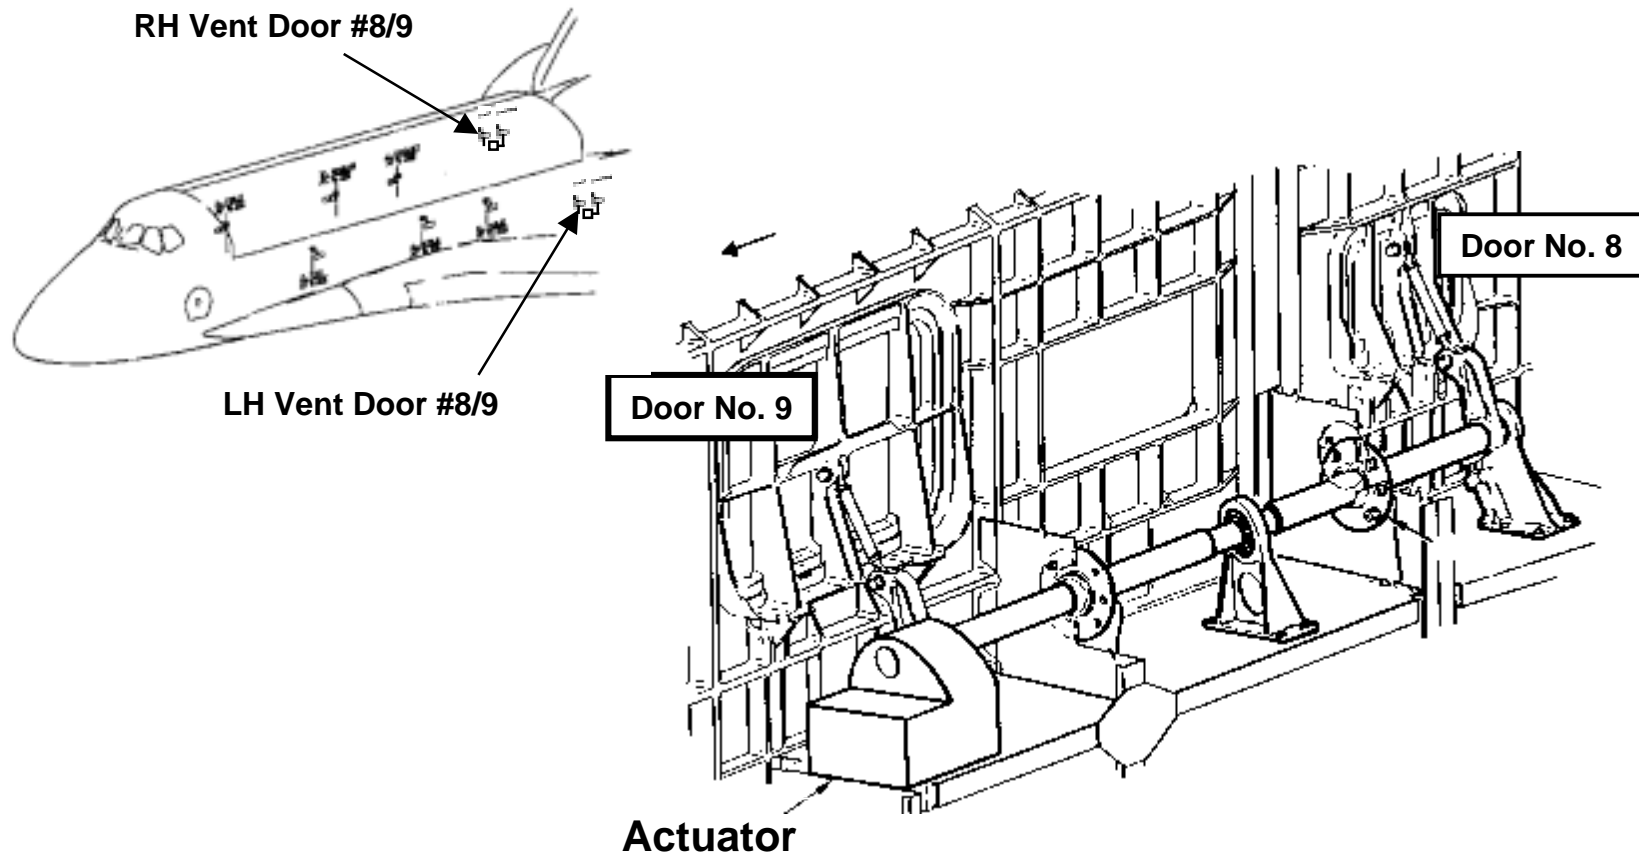
Figure 1: Location of Vent Door 8 & 9 Actuator

- Actuator subjected to and passed ATP
- During dielectric strength test, voltage inadvertently set to over double required level
 - Required replacement of both motors again and three switches
- During second motor replacement, technician noticed one of two gearbox input pinion gears was difficult to rotate by hand
- Gearbox was disassembled to determine cause of binding
- Several observations made upon disassembly:
 - Additional binding found in output shaft planetary gearset (Fig 2)
 - Bearing holes in input pinion gear housing measured and found to be slightly undersized (Fig 2)
 - Possible cause of binding since bearing could not be completely seated
 - One output shaft planet gear had damage on bearing shield (Fig 3)
 - Two loose bearing shields found stuck to the gearbox wall
 - One differential bearing missing shield (Figs 4)

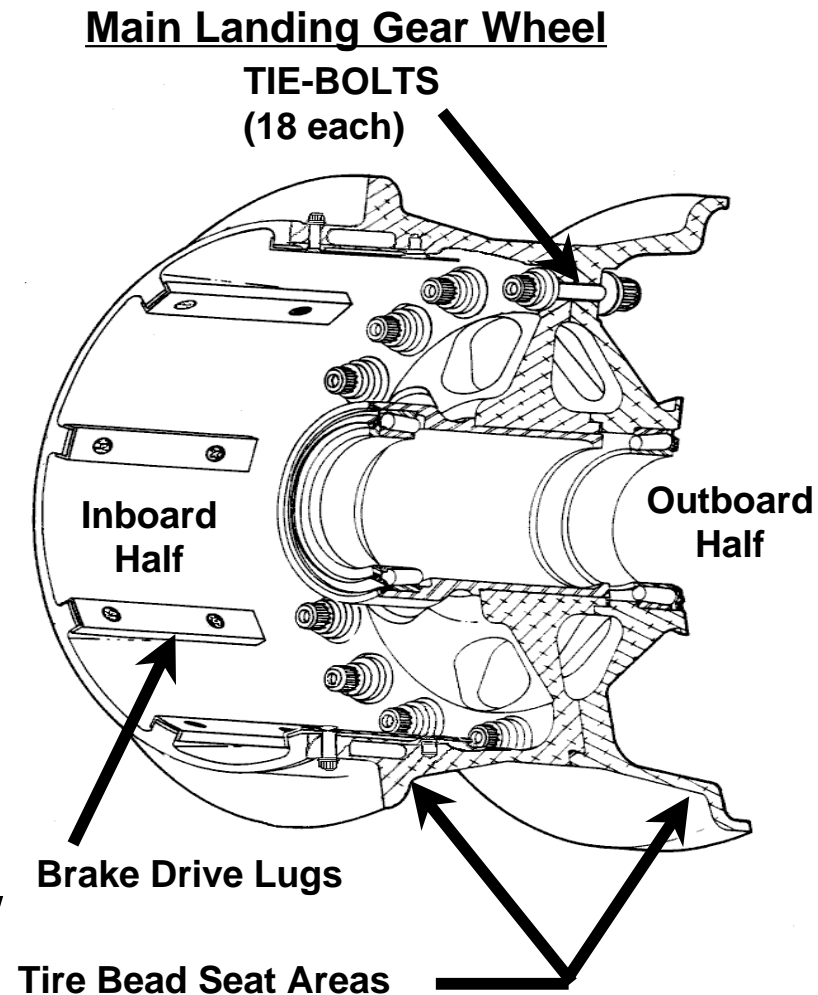
- The Orbiter's MLG wheel is a typical aircraft split wheel design
 - Aluminum wheel halves
 - Chemical film coating and primer/top coat provide corrosion protection
 - Holes And Wheel Halves Mating Surfaces have chem film and primer only
 - High strength Multi-Phase tie-bolts assemble the inner and outer wheel halves together
 - MLG wheels are designated as fracture critical hardware
- Wheels are disassembled and assembled every flow due to one flight use of MLG tire
